## **Silo Failures: Case Histories and Lessons Learned<sup>1</sup>**

**by**  
**Dr. John W. Carson**

<sup>1</sup> Source: Carson, J. W.: Silo Failures: Case Histories and Lessons Learned, presented at the Third Israeli Conference for Conveying and Handling of Particulate Solids, Dead Sea Israel, May 2000

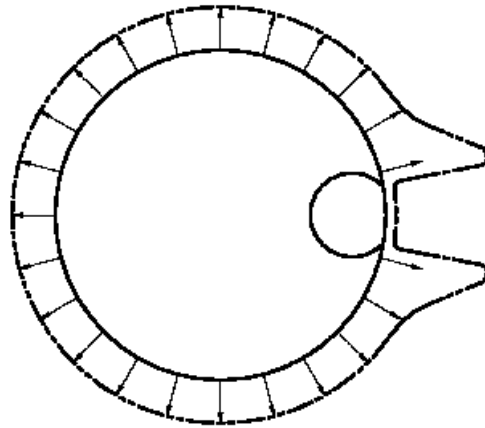
Fig. 1, Non-uniform pressures caused by eccentric withdrawal

This is one of the most common causes of silo structural problems, since it is so often overlooked. It results when the withdrawal point from the hopper is not located on the vertical centerline of a circular silo [7,8], and is particularly common when using silos with multiple hoppers in which only one or two of the hopper outlets are used at a time. If the resulting flow channel intersects the silo wall, non-uniform pressures will develop around the circumference of the silo leading to horizontal and vertical bending moments. See Figure 1. Many silo designers incorrectly account for these non-uniform pressures by only increasing hoop tension. [9,10]

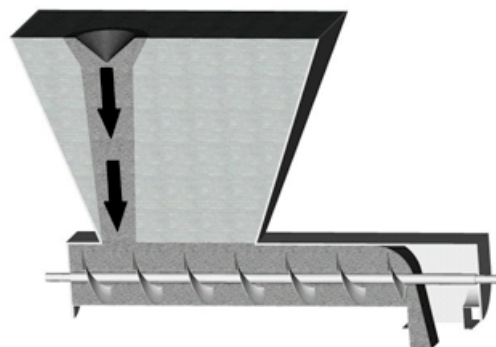
Fig. 2, Constant pitch screw feeder caused eccentric withdrawal

screw feeder. A significant inward dent developed about mid-height in the cylinder section. It extended about one-quarter of the way around the circumference and was centered slightly offset from the long axis of the screw at its back end. The problem was caused by eccentric withdrawal due to an improperly designed screw feeder. See Figure 2.

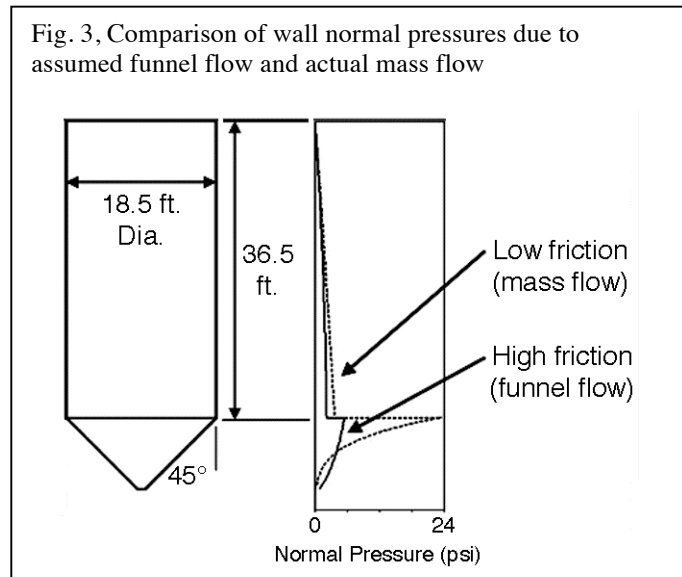
Fig. 3, Comparison of wall normal pressures due to assumed funnel flow and actual mass flow

the top of the hopper section. Although the silos were designed structurally for funnel flow, no flow tests were performed to see if this flow pattern would occur. Lab tests performed after the failure showed that mass flow developed along the 45° cone walls. See Figure 3.

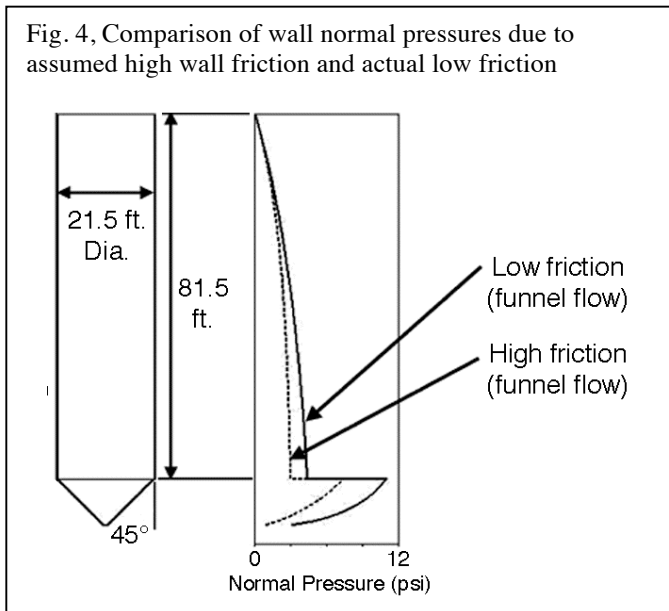
Fig. 4, Comparison of wall normal pressures due to assumed high wall friction and actual low friction

- Two similar bolted silos also storing plastic pellets failed in a similar manner. Lab tests showed that the wall friction was not low enough for mass flow. However, the wall friction angle was much lower than the silo designer assumed. Thus, less of the pellet mass was supported by shear along the vertical cylinder walls, resulting in much higher wall pressures in the hopper than was assumed by the designer. See Figure 4.

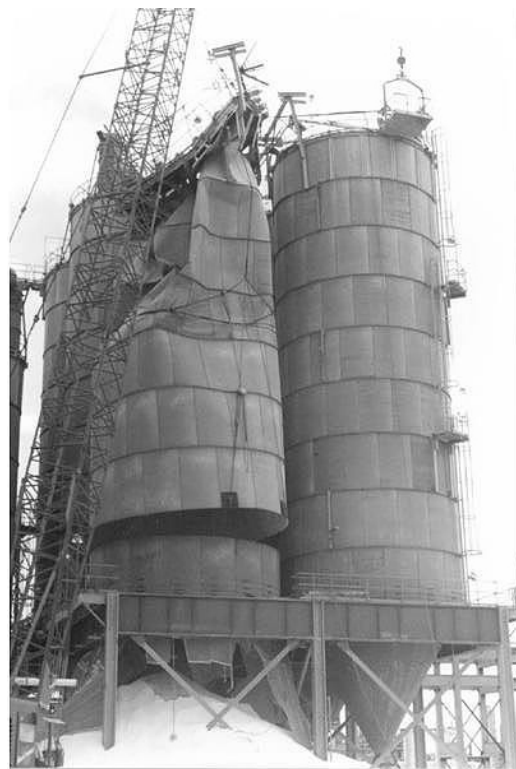
Fig. 5, End-result of mass flow developing in a silo designed structurally for funnel flow

- Six 7.9 m diameter by 22 m. tall silos were used to store high-density polyethylene fluff and pellets. Below each cylinder section was a 30° cone terminating at a rotary valve feeder. A radial hopper seam split open on one silo, spilling one million pounds of material onto the ground. The cause of this failure was determined to be mass flow loads. The silo was structurally designed only for funnel flow. See Figure 5.
- Four outdoor bolted silos were used to store barley and corn. As with the previous example, failure occurred by splitting of a radial seam near the top of the hopper, which was the result of unexpected mass flow loads. In this case, the cone walls were

apparently polished by the barley, and the wall friction decreased further when the outside air temperature dropped below freezing.

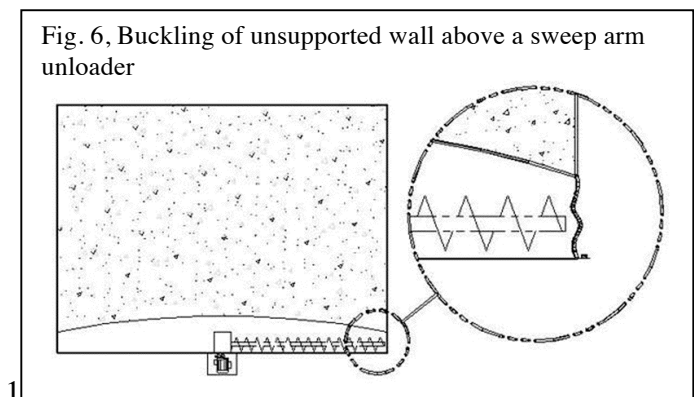
- A 7.6 m diameter by 27 m tall bolted flat-bottom silo was used to store soybean meal. Discharge occurred by a sweep arm screw unloader. The material's flow properties varied considerably, from free flowing to extremely cohesive. An arch formed above the unloader, and spanned the full diameter of the silo. Material below this was removed by the unloader, so the full one million pounds was transferred to the unsupported thin silo wall causing it to fail by vertical buckling. See Figure 6.
